Offshore Gas Turbine

Exhaust Refurbishment

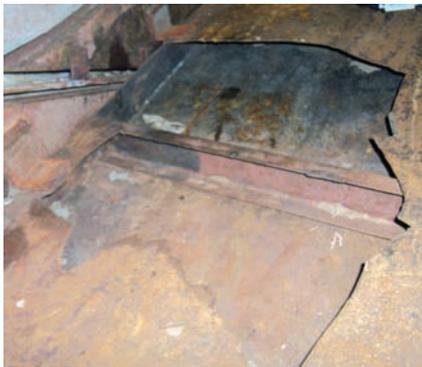
Internal damage to a Frame 5 gas turbine exhaust outlet plenum

The internal thermal lining had suffered problems resulting from previous maintenance work, and this led to the emergency shutdown of the main gas compression gas turbine to implement root cause failure analysis and also the swift re-instatement of the machine.
